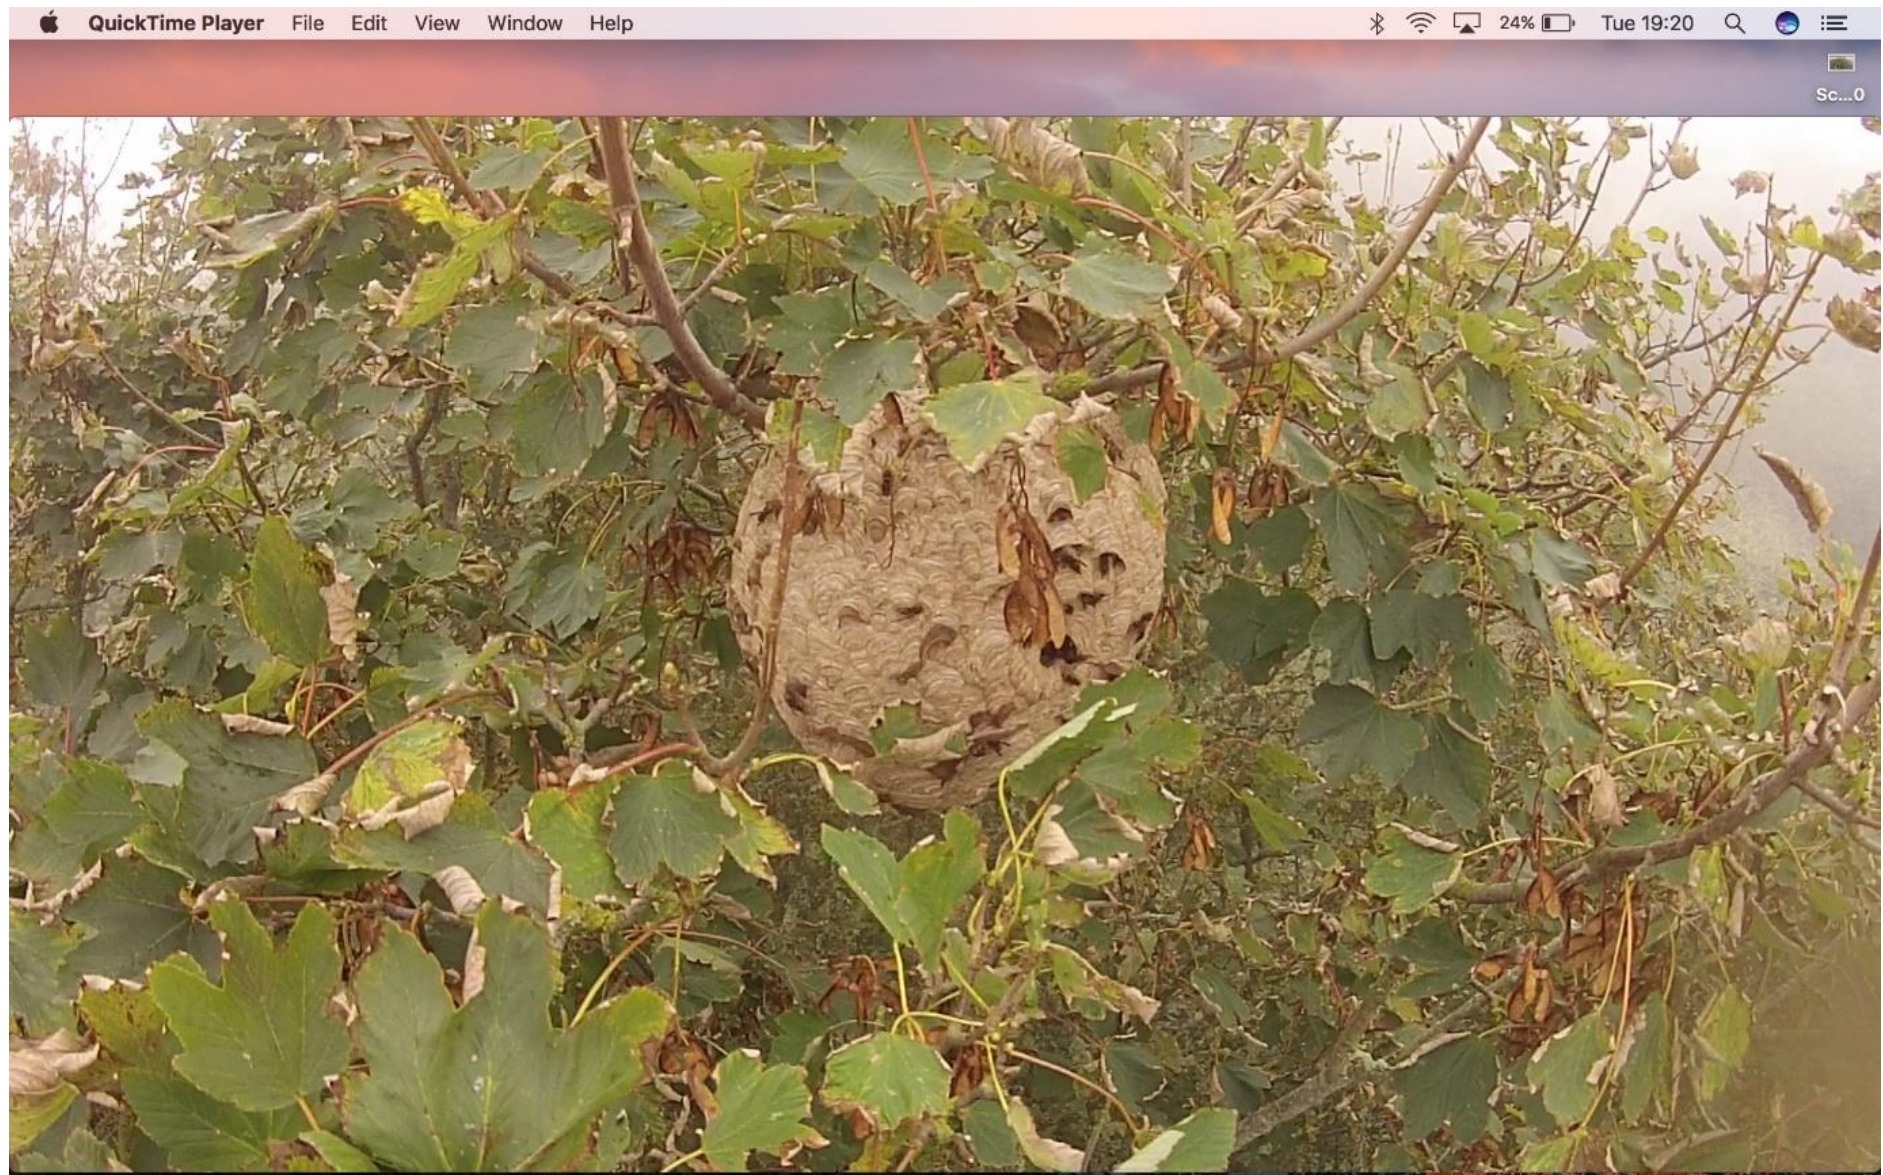
Image 1 – Drone footage still showing ventilation and entry holes
